DEPARTMENT OF TRANSPORTATION

Quality Assurance and Source Inspection

Contract #: 04-0120F4Cty: SF/ALA Rte: 80 PM: 13.2/13.9File #: 69.28**WELDING INSPECTION REPORT****Resident Engineer:**Siegenthaler, Peter**Address:** 333 Burma Road**City:** Oakland, CA 94607**Report No:** WIR-024171**Date Inspected:** 26-May-2011**Project Name:** SAS Superstructure**OSM Arrival Time:** 700**Prime Contractor:** American Bridge/Fluor Enterprises, a JV**OSM Departure Time:** 1900**Contractor:** Zhenhua Port Machinery Company, Ltd (ZPMC), Changxing Island **Location:** Shanghai,China**CWI Name:** Liu Hua Jie/Lv Li Qing**CWI Present:** Yes No**Inspected CWI report:** Yes No N/A**Rod Oven in Use:** Yes No N/A**Electrode to specification:** Yes No N/A**Weld Procedures Followed:** Yes No N/A**Qualified Welders:** Yes No N/A**Verified Joint Fit-up:** Yes No N/A**Approved Drawings:** Yes No N/A**Approved WPS:** Yes No N/A**Delayed / Cancelled:** Yes No N/A**Bridge No:** 34-0006**Component:** OBG**Summary of Items Observed:**

OBG Trial Assembly

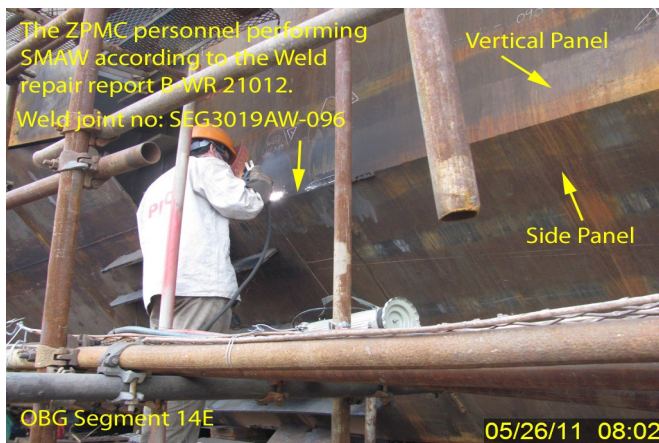
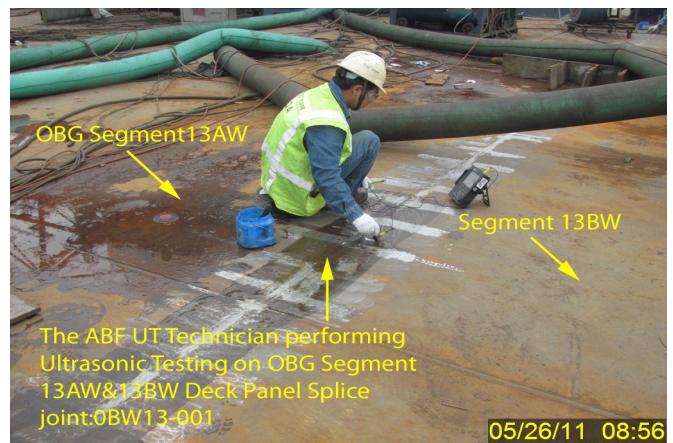
SMAW welding of weld joint No: SEG3019AW-096 located on OBG Segment 14E Vertical panel to Side panel. Welder is identified as #215553. ZPMC QC is identified as Mr. Zhu Yuan Yuan. Welding was performed with the weld repair report BWR-21012. The welding variables recorded by QC appeared to comply with the WPS-345-SMAW-2G(2F)-FCM-Repair-1. Please see the attached picture.
